ERDC/CRREL TR-03-8

Remote Determination of Bridging/Fording Sites

Barry Coutermarsh and Sgt. Benjamin Dwinal

April 2003

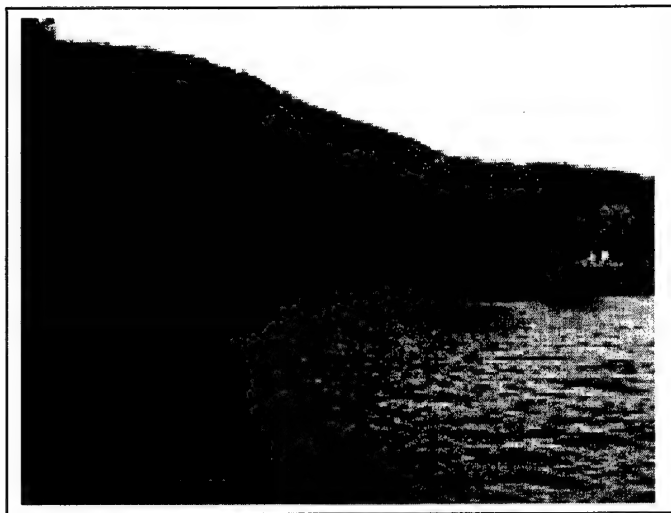
**West bank of site
12. It is too steep
to traffic.**

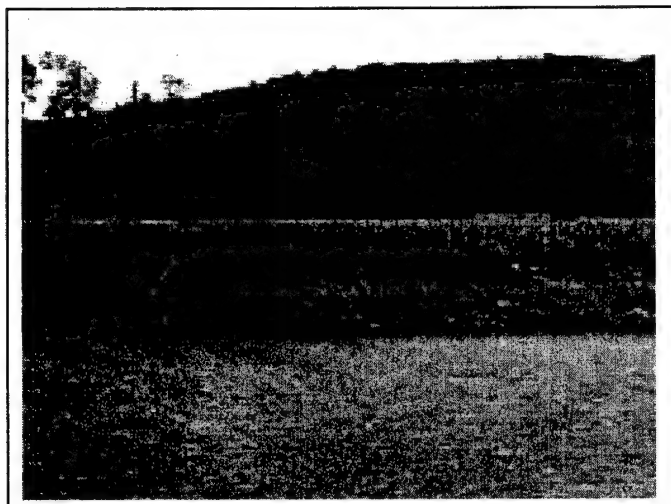
**East bank of site
12. It is too steep
to traffic – 90° in
spots.**

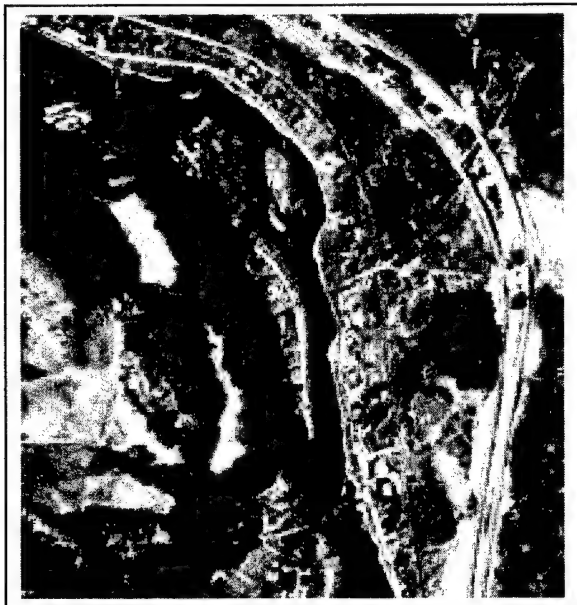
Aerial photo of site 14, which was chosen as a possible AVLB site but proved to be too wide. There is a large amount of ledge outcroppings in the water that are not evident in the aerial photo.

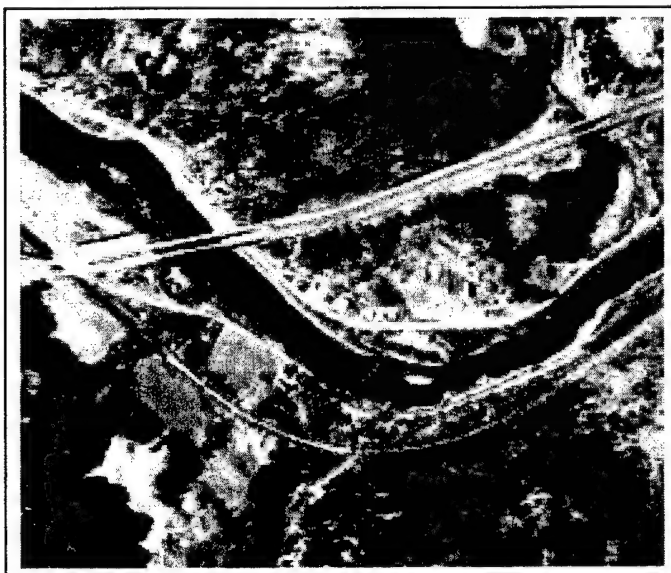
Aerial photo of site
15. The site was
chosen as a
possible AVLB
site, but it is too
wide.

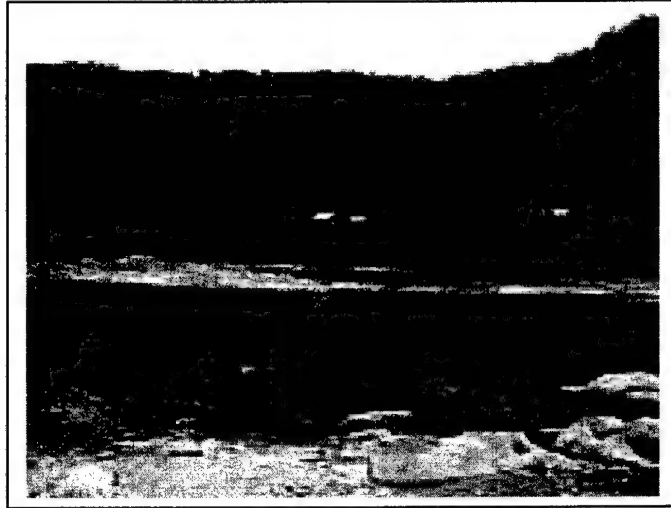
West bank of site 15. The initial slope is trafficable, but there is a secondary bank about 8 to 10 ft high and almost 90° leading to a road at top that cannot be negotiated.

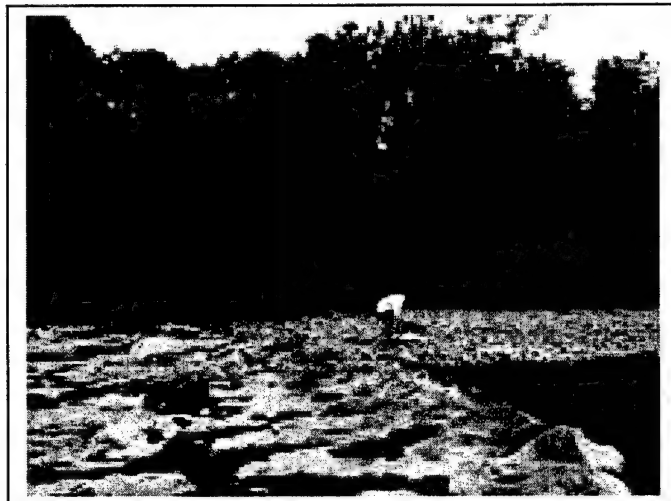
East bank of site 15. The bank is about a 20° slope and looks trafficable.

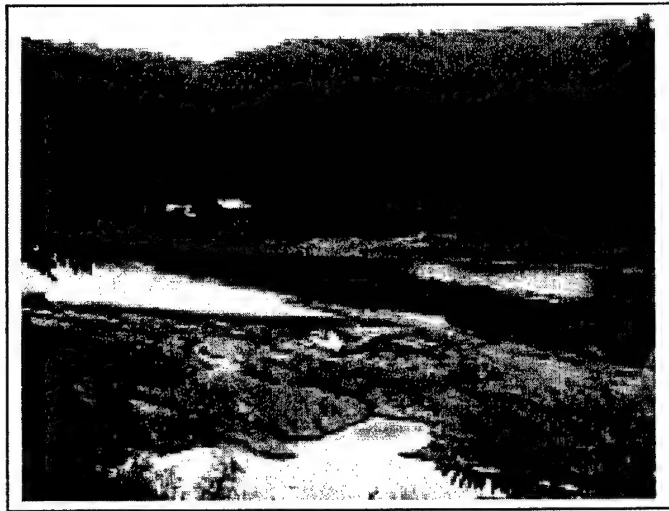
West bank of site 16. It has a good low-slope approach.

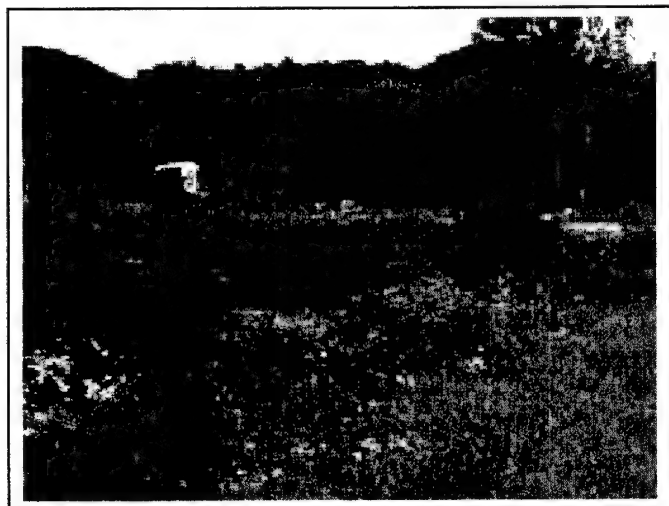
East bank of site 16. The bank is not trafficable; it is approximately 15 ft high and very steep, leading to a road at the top.

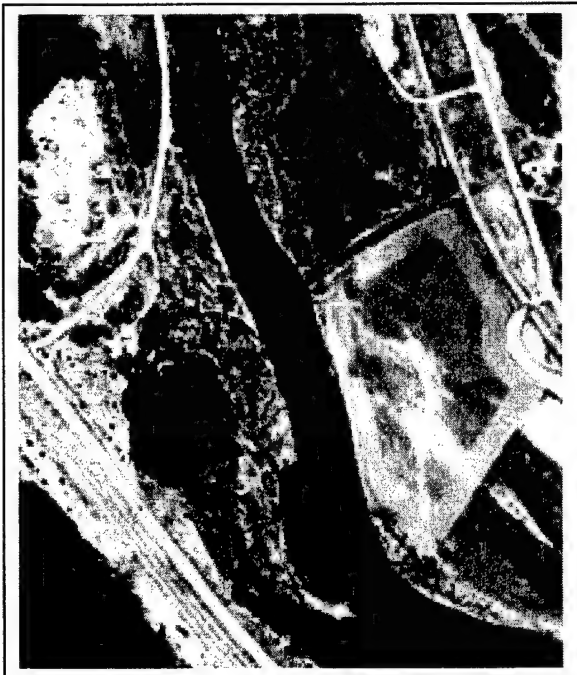
**Aerial photo of site 17.
The site was initially
chose as a possible
AVLB site, but it was too
wide.**

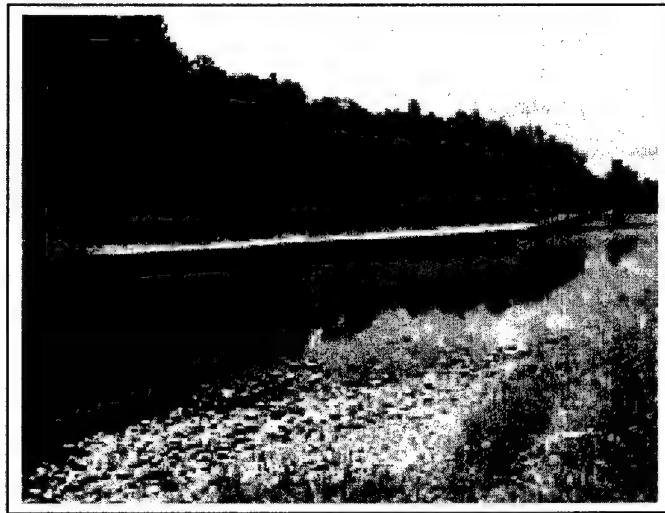
West bank of site 17. The bank starts nearly flat at the water, increases slope to about 19° , then flattens to about 10° with a total height of about 9 ft.

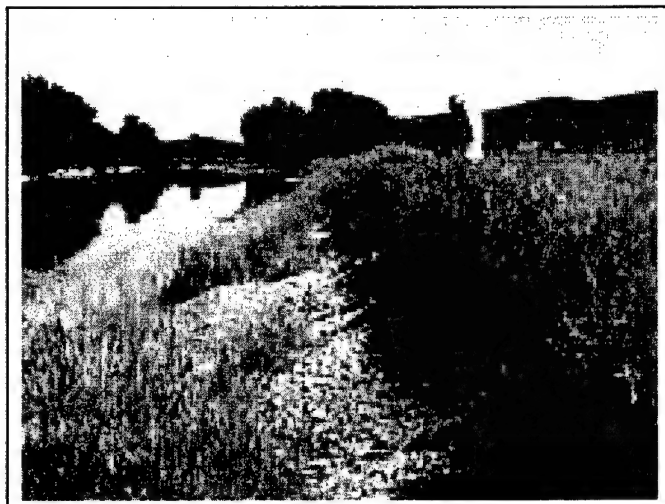
East banks of site 17. The bank is 8 to 10 ft high with some portions 90° at the top.

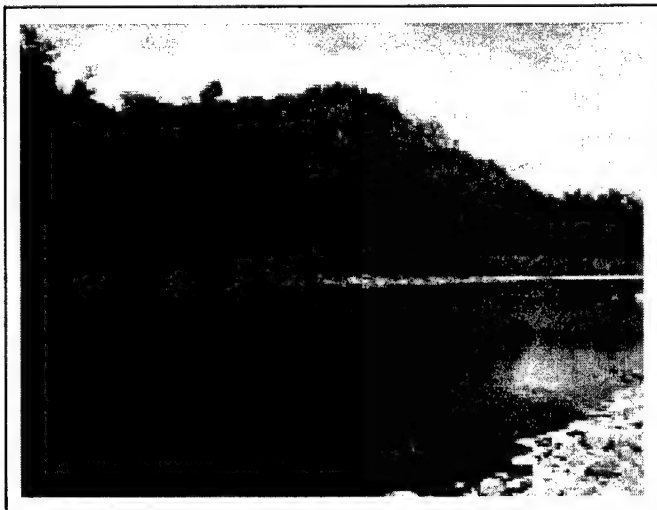
**West bank of site 18. The land leads into the water with no abrupt bank. The bank has a 24° slope in spots.**

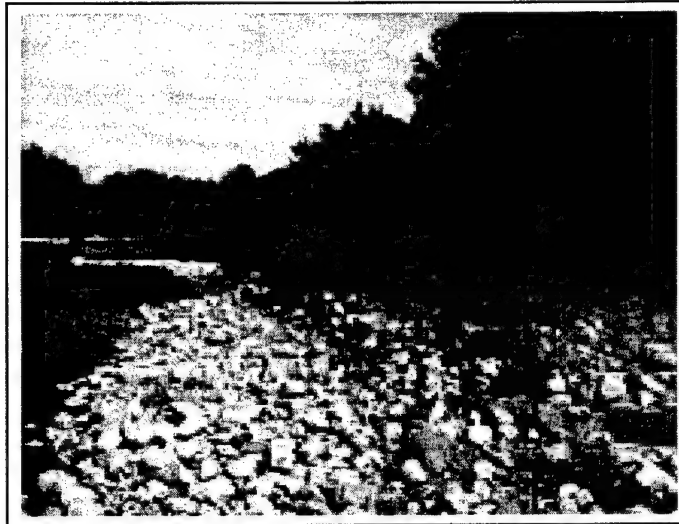
East bank of site 18. The land leads into the water with no abrupt bank. This bank is approximately 20°.

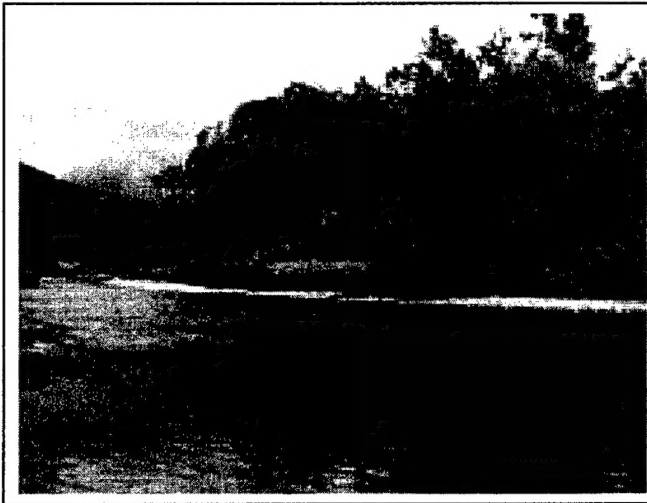
East bank of site 20 looking north. The bank is trafficable with an initial low slope out of the water, then a 1- to 2-ft-high secondary bank and level beyond.

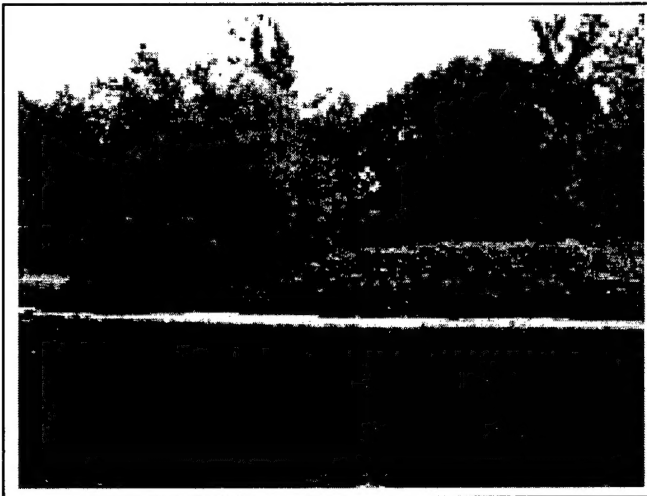
East bank of site 20, looking just south of the shot above. The bank is trafficable with an initial low slope out of the water, then a 1- to 2-ft-high secondary bank and level beyond.
